# Accessibility Assessment

CN Tower - January 2019

Caleb Van Esch, Van Esch Enterprises  
Jenny Blome, Manager, Accessibility Services  
Rick Hansen Foundation  
[jblome@rickhansen.com](mailto:jblome@rickhansen.com)  
(778) 869-2003

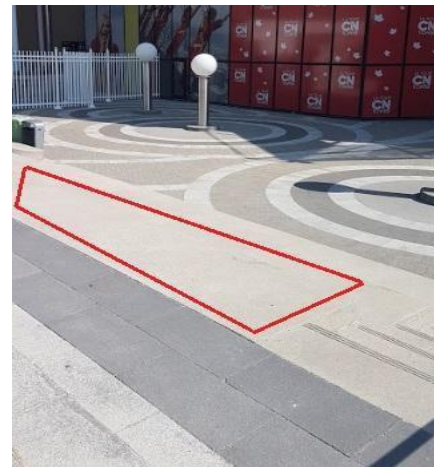
**Right Illustration:** Top edge of lowered seating area, showing upper surface that blends into surface below creating fall hazard. A high contrast tactile indicator strip should run along top of fall hazard.

- Edge protection or highly visual tactile indicators should be placed along top of drop-off of the lowered exterior seating area.
- Obstacles positioned along path of travel should visually contrast with walkway to help highlight items.
- Additional directional signage can be placed at the Bremner Blvd. approach and path of travel.
- A high contrast surface and/or directional tactile indicators can be placed along direct paths of travel from property line to CN Tower entry point.
- PATH from Union Station to the CN Tower has poor accessibility. Although, this is not an aspect that is controlled by the CN Tower, improvements would certainly enhance the accessibility of the exterior approach. Consider making a request to the City of Toronto to increase accessibility along the PATH from Union Station to the CN Tower.

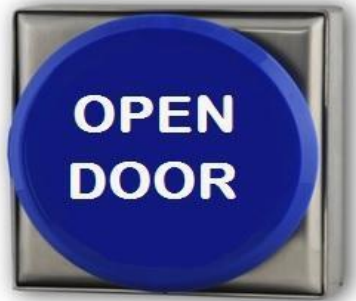
**Left Illustration:** Door open button with colour; using non-segregating language or symbols.

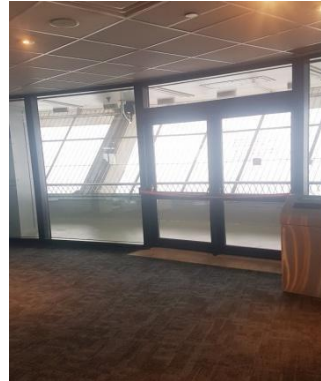
**Right Illustration:** Glazed window and door system on Level 2 viewing deck lacking visual indicators on glazing.

7. Doors should visually contrast surrounding walls and floor. Although most doors have adequate contrast not all doors adequately contrast surrounding surfaces.

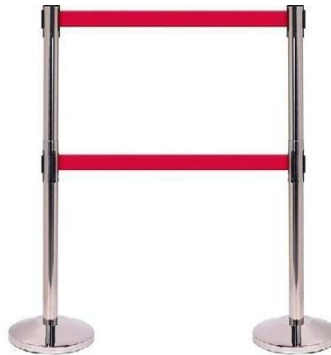
**Left & Right Illustrations:** Line stanchions should be detectable. Illustration on right shows a stanchion that is detectable and includes colour.

1. Crowd control stanchions used along path of travel from Concierge area to Liffoff area should be cane detectable, maximum 680mm above finished floor. Stanchions should also visually contrast floor area where they are placed.
2. Items placed along path of travel should not infringe on path of travel and should be highly visible. Objects include: pillars, garbage's, floor signs, seating and tables, interactive seating on Level 3 viewing area.
3. Main path of travel through Retail Store can be narrow and does not allow smooth traffic flow.

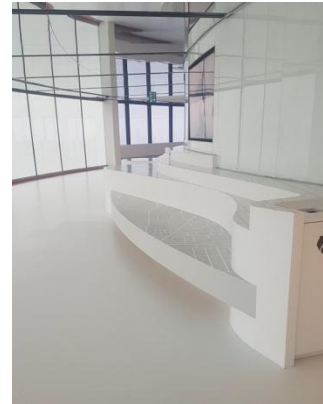
**Far Right Illustration:** Many items on Level 3 viewing area have limited visual contrast to surrounding surfaces.

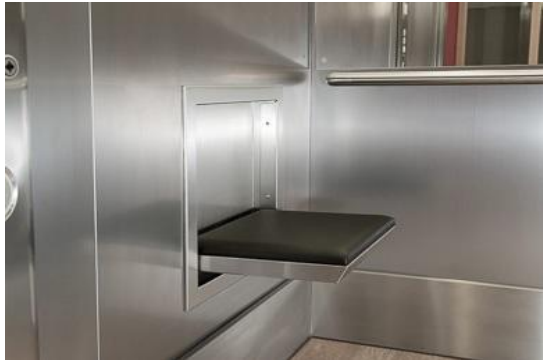
**Left Illustration:** Fold down elevator chair that is flush with wall when folded up.

4. Handrails within main elevators are a flat, non-graspable design. Round handrails are easier to grip.
5. A fold down chair can be provided to assist visitors who may be unsteady on their feet.

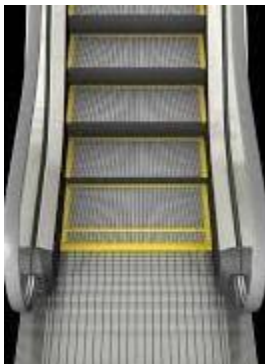
**Left Illustration:** An example of an escalator with high contrast nosing and continuous strip along the side.

1. A high contrast marking should be provided on step nosing and run alongside of escalator steps.
2. Tactile walking surface indicators should extend along the entire landing at top and bottom of escalator. The surface indicators should also be a contrasting colour to surrounding surface.
3. The direction of the escalator should be clearly signed and indicated.

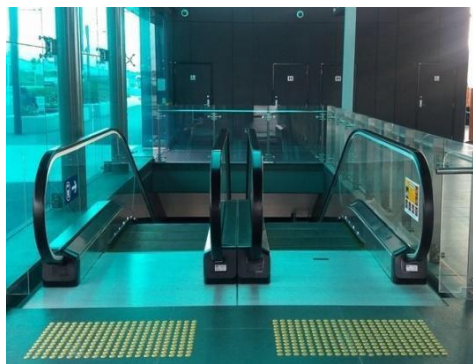
**Right Illustration:** An example of an escalator with high contrast tactile indicators at landings.

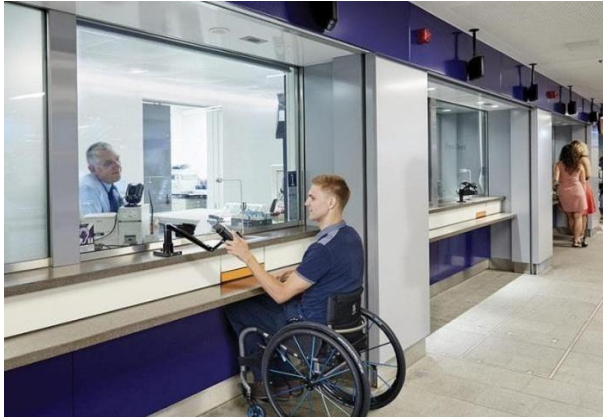
**Illustration:** Example desk shows universal height service counter, with accessible knee recess. Also note the contrast between floor and counter colour. Payment machines are within reach of a person in seated position.

1. Service counters located throughout the CN Tower are very high (960mm) and may not be accessible while seated. Service counters should be lowered to an accessible height. Desk heights between 730-860mm are a universally accessible height making them more accessible to a greater number of people.
2. There is often limited knee recess or overhang at service counters. Knee recesses should be available at all counters.
3. Signage above service desks indicating purpose of desk, should have good legibility. Lettering should be a solid colour with a solid background.
4. Informational signage at service windows should be available with raised lettering and Braille.

5. Service desks should colour contrast the surrounding floor and wall surfaces. This makes the service desks visually distinguishable from surroundings surfaces.

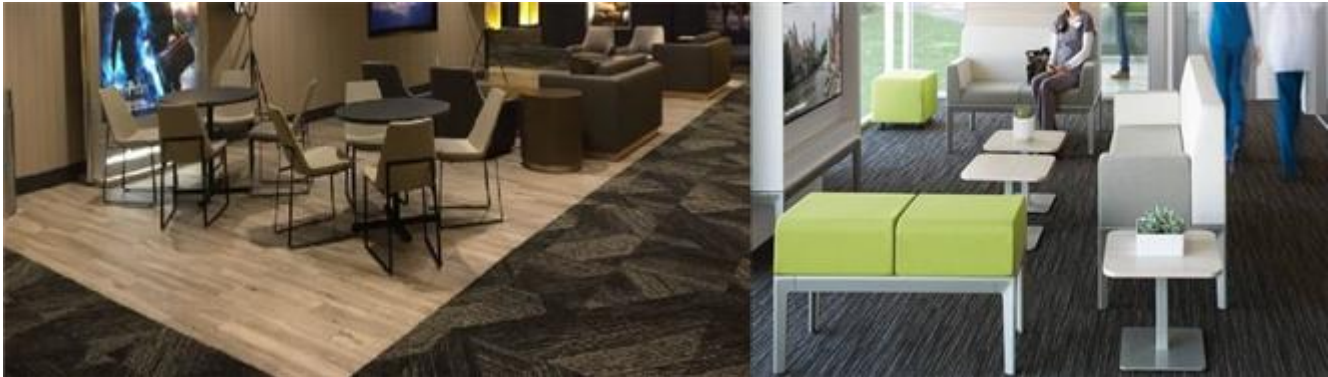
**Left Illustration:** Shows a universal designed seating area. Note the distinct floor contrast between seating area and circulation route. Also note the variety of seating options including seating with arm and back support.

**Right Illustration:** Shows colourful seating options that offer obvious contrast to floor surface. Note the rounded corners of the tables.

1. Although a seating area is located in the lower Le Cafe area, there is limited designated seating at the Ticket sales or Concierge area. It is recommended that a seating area be added in close proximity to the Concierge area. This will allow patrons that may have limited mobility endurance to rest after purchasing tickets and before touring the CN Tower.
2. Seating options should include seating options with a variety of support, colours, and shapes styles. Surface should be neutral patterns with non-slip upholstery.
3. Seating should also be arranged that there are clear spaces beside seats to accommodate people using mobility aids or service dogs.
4. Tables located in waiting areas should have rounded corners and edges.

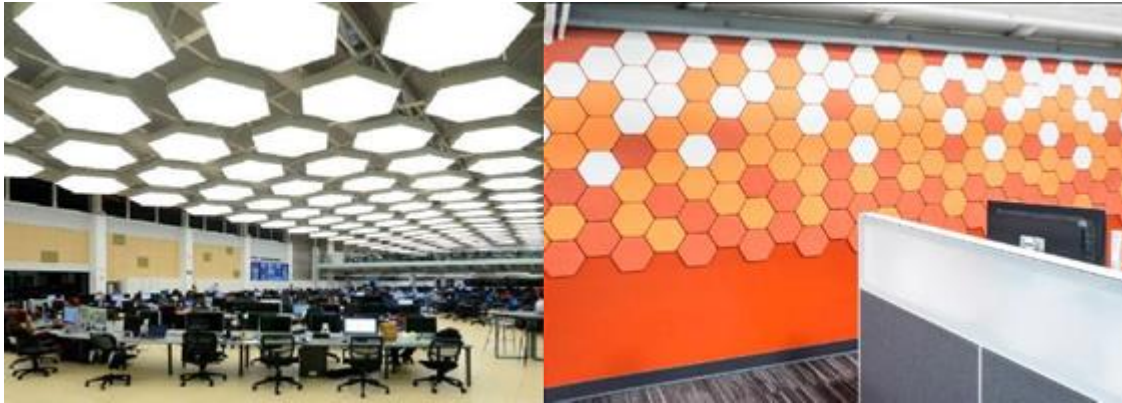
**Left Illustration:** Shows a large open space with an acoustical stretch ceiling.

**Right Illustration:** Shows an acoustical wall surface solution.

1. Sound dampening should be installed at transaction points or where other information transferred audibly. This is especially important in larger areas where background noise can interfere with verbal transactions.
2. Where public announcement systems are installed and may be regularly used, a PA system should use a direct induction loop to connect to hearing aid devices. This enables public service announcements to be made without causing echoing or feedback which can damage a person's ear.
3. Sound dampening technology and architectural features should be increased along halls and in areas where large numbers of people are expected to be gathered. This will help cut down on background noise which may make it difficult a person who may rely on sound to navigate through spaces.

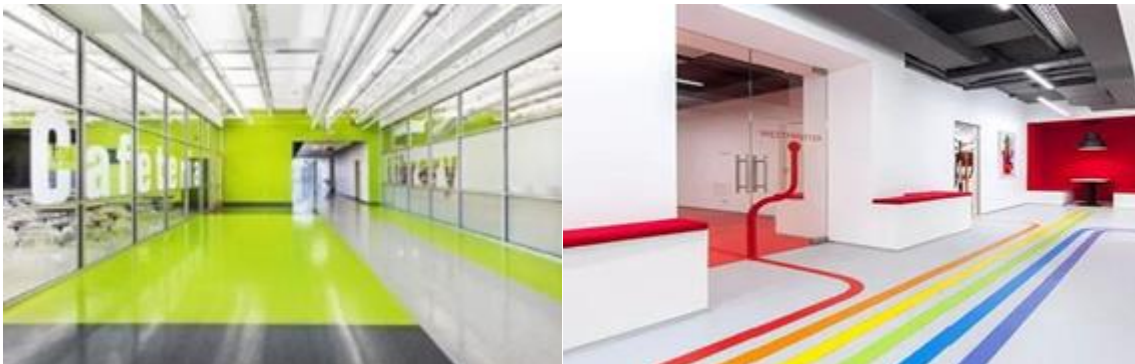
**Left Illustration:** A zone using colour to provide distinct identity. Note the obvious distinguishable path of travel.

**Right Illustration:** Colourful surface finishes being used to guide visitors along path of travel to certain zones.

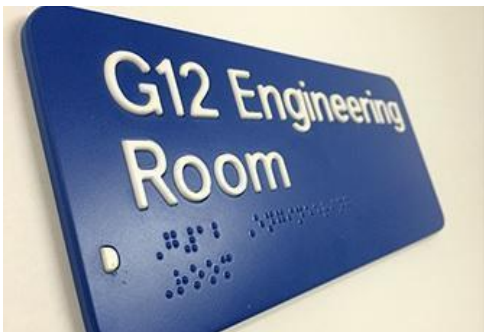
**Illustration:** Example room sign including raised lettering and Braille. Note the high contrast colour font.

1. Room signage should be included on utility rooms, medical and sick rooms and support features.
2. Room signage font should have solid colour background and high contrast text.
3. Room signs should include raised lettering and Braille.
4. Text on signs should be limited to only necessary information and simply worded. This helps to reduce reading time and confusion.
5. Signs are often placed on doors. Room signage should be consistently on the wall of the latch side of the door.
6. Lettering must visually contrast with the background of sign.
7. Meeting and office rooms should include logical numbering system.

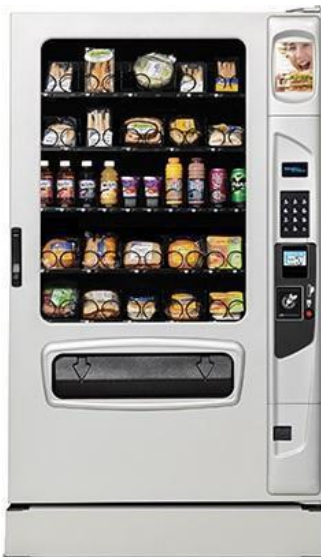
**Illustration:** Example of an accessible vending machine with lowered buttons and payment options. Also note the higher food retrieval slot, eliminating need to reach down.

7. Vending machine buttons should be raised and include raised lettering and Braille.

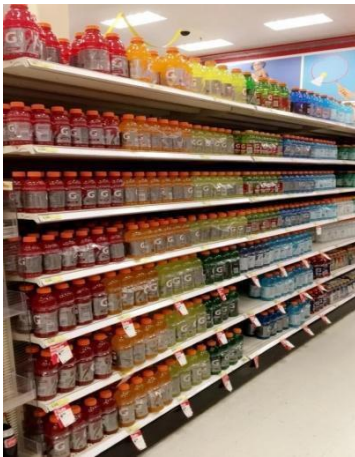
**Left Illustration:** Example of vertical product arrangement on retail shelving, where products are available in standing or seated positions.

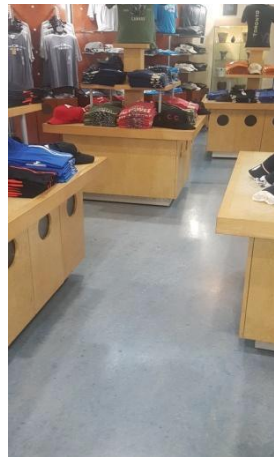
**Right Illustration:** Narrow pathways and pinch points in CN Tower retail store.

1. Service counters should be at an accessible height and offer adequate knee space to accommodate a person using a mobility aid.
2. Clear width between merchandise tables and racks should be a consistent width allowing a person using a mobility aid to easily travel without encountering pinch points.
3. Merchandise table and racks should be placed in an accessible layout that enables a person using a mobility aid to approach easily.
4. Merchandise on tables and racks should be arranged in a manner that they are accessible from seated or standing positions.
